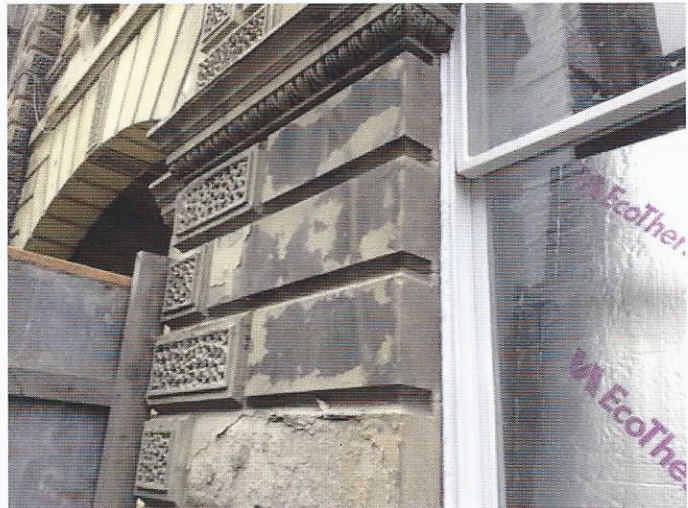
16. IN 2014 WE PIONEERED THE USE OF SILICIC ACID STONE CONSOLIDATORS IN THE NORTH OF ENGLAND. THE PRODUCTS WILL OVER TIME DEPOSIT SILICON OXIDE (SiO<sub>2</sub>) BACK INTO THE SANDSTONE STRUCTURE TO RE-ESTABLISH THE STONE'S COMPRESSIVE STRENGTH. THUS, ON PIECE OF BADLY SPALLED SANDSTONE LOOSE MATERIAL IS LIGHTLY BRUSHED OFF, AFTER CLEANING, AND THE STONE FLOOD COATED CONSOLIDATOR. AFTER 4 WEEKS THE PROCESS IS REPEATED AND THE STONE WILL REGAIN 95% OF ITS ORIGINAL STRENGTH. THE BUILDING AT 10, RAILWAY STREET HUDDERSFIELD WAS ENTIRELY TREATED IN THIS FASHION. SUBSEQUENTLY WE HAVE USED THIS TECHNOLOGY ON A NUMBER OF OTHER LISTED BUILDINGS WITH CRUMBLING SANDSTONE.

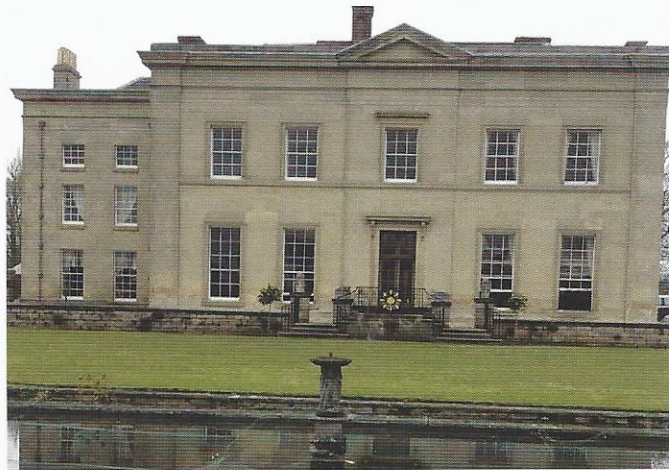
***17. We have cleaned several "stately" homes and on our last project (in South Derbyshire) one elevation of the building was inaccessible to a cherry picker as it would have involved crossing several delicate grassed areas. We therefore purchased our own 12m steel scaffold tower and trained our men in the safe use of the K-Lok scaffolding system.***

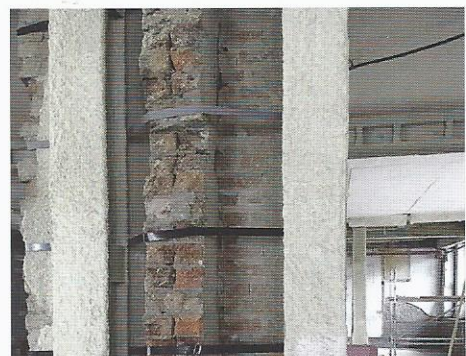
18. In 2015 we adapted steel strapping technology to strengthen poorly constructed internal support columns in a Grade II listed building in Liverpool.
